Blackwell Hall Farm - Baseline report

Part A – Modular River Survey

Smarter Water Catchment Programme

July 2024

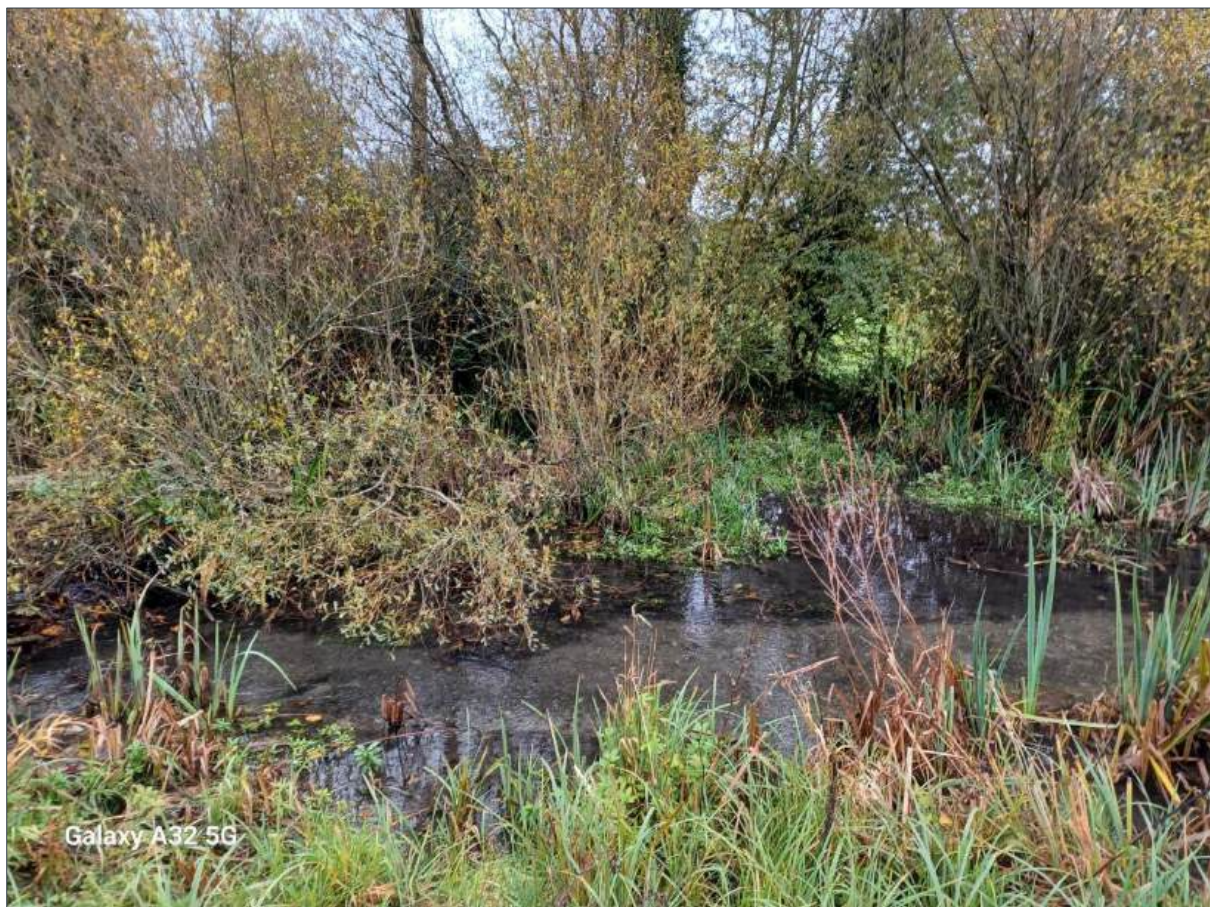
Figure 1.1: General view of the River Chess at the Blackwell Hall Farm site (subreach 5) taken during the baseline MoRPh surveys.

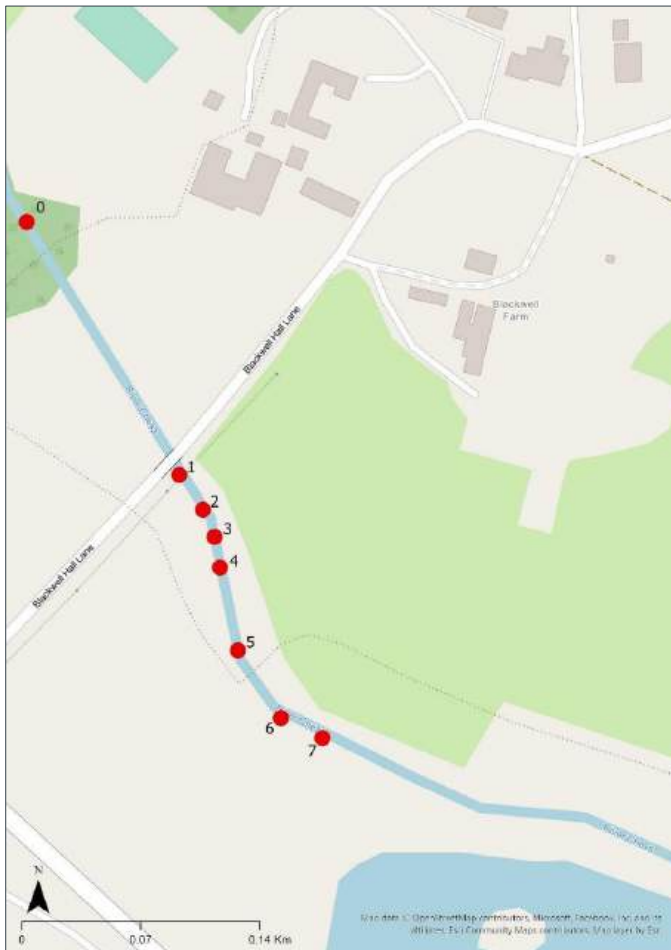
Figure 1.2 Map of the River Chess at the Blackwell Hall Farm site, showing the locations of the MoRPh subreaches (red circles).

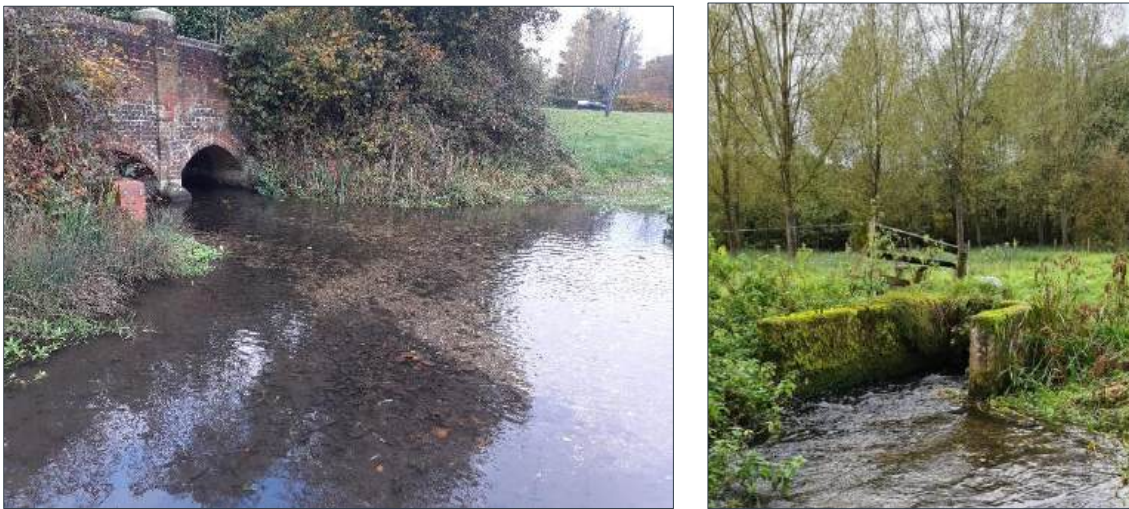
Figure 2.1: Photo of the culvert under Blackwell Hall Lane Road, taken at Subreach 1 (left). Photo of the outfall associated with the Chesham Sewage Treatment Works, taken at Subreach 7 (right).

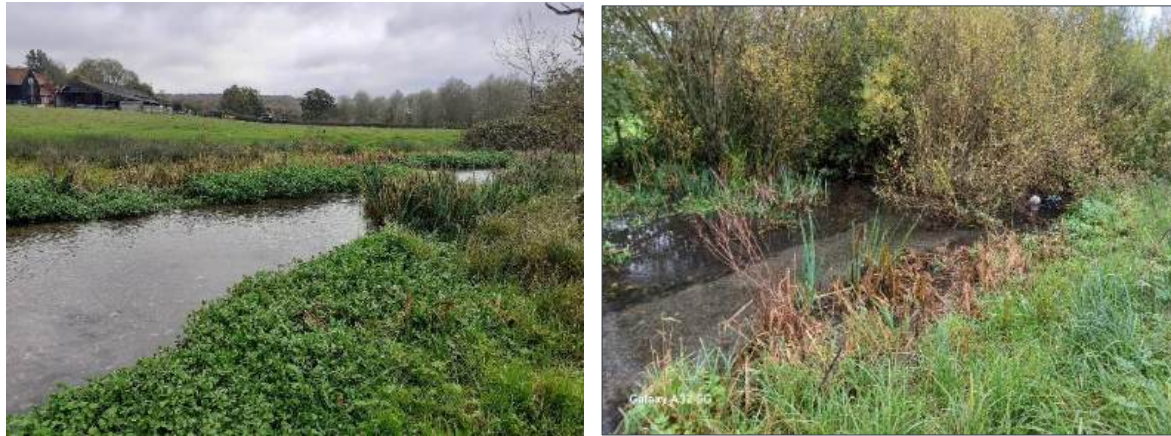
The baseline MoRPh data (Figure 2.5 and Figure 2.6) shows the number of flow types (Index 1) was recorded as two at the majority of subreaches (Figure 2.2). This is on average relatively low, about the same as the UK chalk stream average, but below the number of flow types that the river should naturally contain (pre-modification). Index 2 illustrates the highest energy flow types recorded were rippled, unbroken standing wave and smooth.

Figure 2.2: Photos of the lack of flow diversity taken at Subreach 1 (left) and Subreach 5 (right).

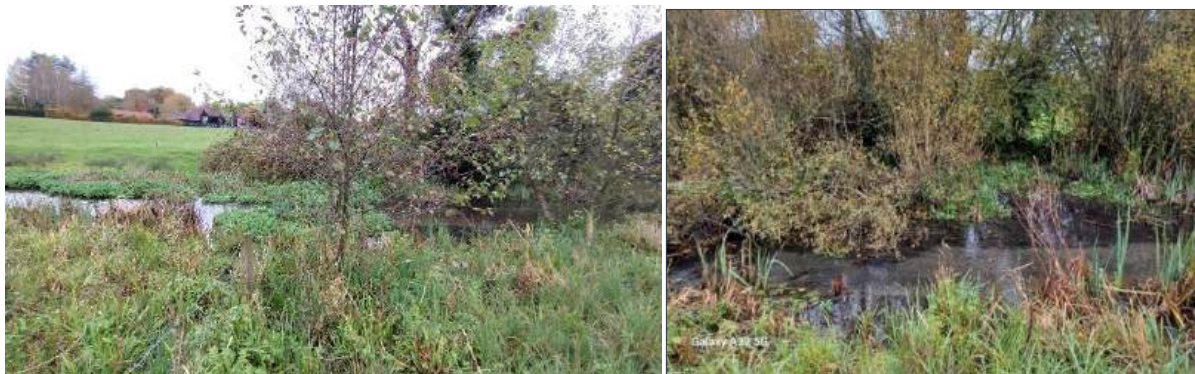
On average, channel physical habitat complexity (Index 8) was about average for UK chalk streams and the River Chess catchment whereas the average number of aquatic vegetation morphotypes⁴ (Index 9) was higher than the UK rivers and UK chalk stream averages (Figure 2.3).

Figure 2.3: Evidence of the average channel physical habitat diversity and aquatic vegetation morphotypes. Taken at Subreach 3 (left) and Subreach 5 (right).

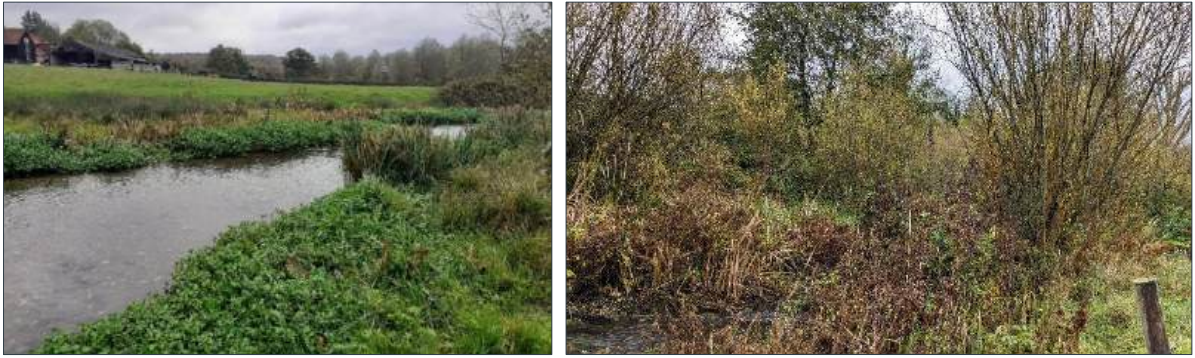
Riparian physical habitat complexity (Index 10) and the riparian vegetation structural complexity (Index 11) were both on average poor in comparison with the average for all UK rivers and UK chalk streams. The small variation in riparian physical habitat further illustrates the low complexity of the riparian habitat. This is likely reflecting the absence of riparian vegetation at some subreaches and the highly overgrown vegetation at other subreaches (Figure 2.4).

Figure 2.4: Photos of the variation of riparian vegetation complexity shown by a lack of riparian physical habitat and structural complexity at Subreach 1 (left) and more complex and highly overgrown riparian vegetation at Subreach 6 (right).

- Installation of 310m of stock proof fencing along both banks of a portion of the River Chess that passes through Blackwell Farm. The new fencing will exclude livestock from the river and river banks where they have unrestricted access. The new fence will be set back 3-5m from the channel banks.

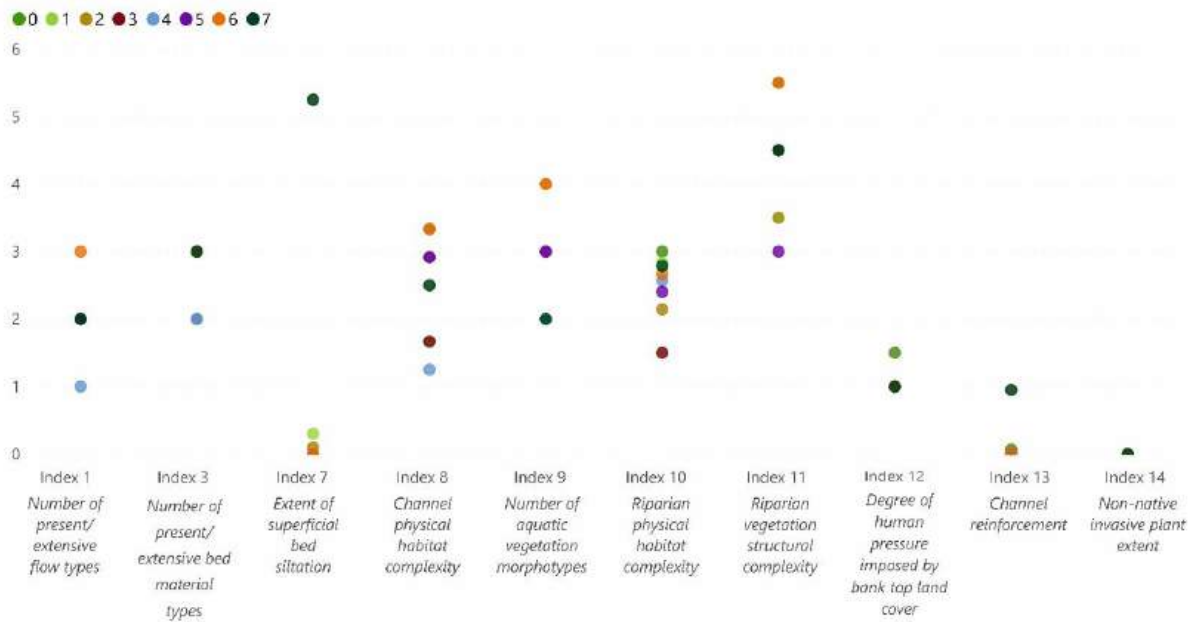
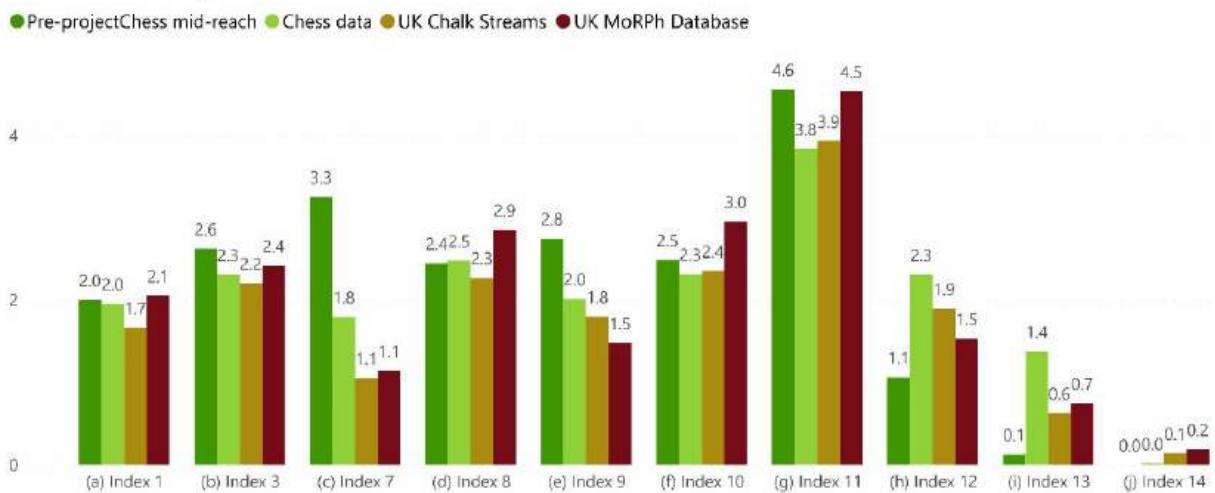
Average Index value at Blackwell Hall Farm

Index value comparisons

Figure 2.5: Summary of the baseline averages of the MoRPh indexes⁵ per subreach from the Blackwell Hall Farm site. Also shown are index value comparisons for all MoRPh surveys on the River Chess (light green), UK average chalk stream values (brown), and average values for all rivers within the Citizen Science MoRPh database (red).

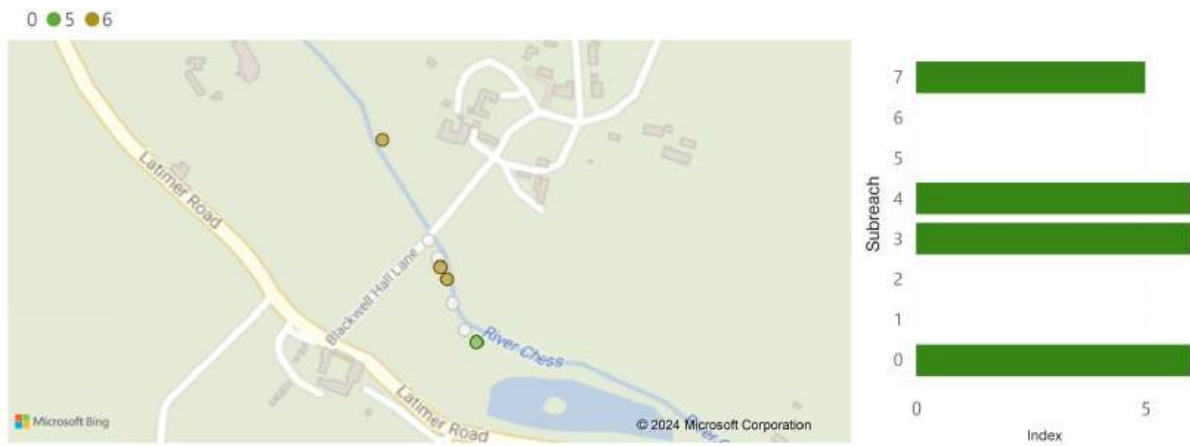
INDEX 7: Extent of superficial bed siltation

A detailed breakdown of bed siltation along the channel within the site is shown in Figure 2.7. Index 7 illustrates the extent of silt of the channel bed recorded by the trained citizen science surveyors. UK chalk streams are expected to have relatively low levels of silt across the channel bed as a high proportion of the flow is groundwater fed.

Figure 2.7: Index 7 at each subreach.

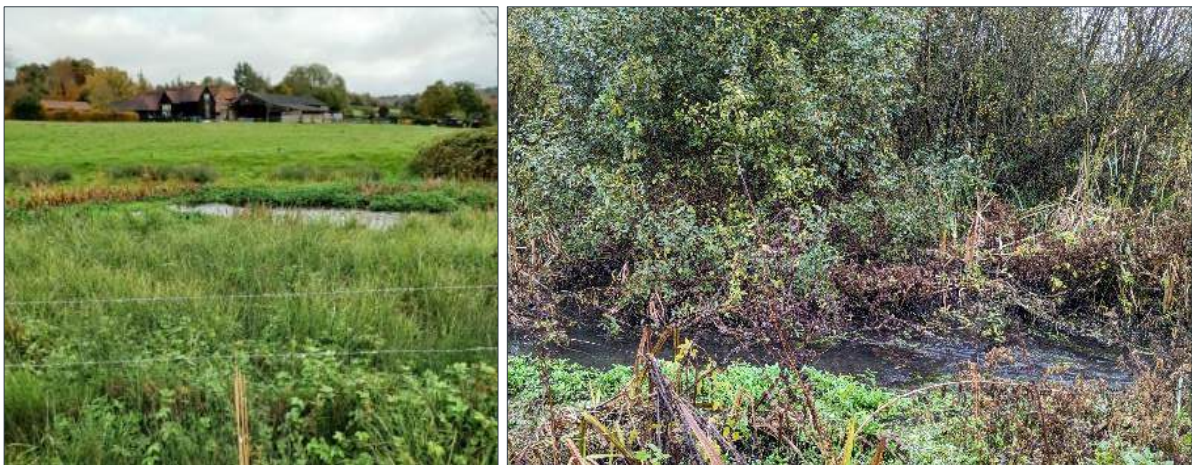
Within the site, the extent of bed siltation recorded varied extensively which can be linked to the bank conditions. In subreaches with little riparian cover there may be higher extents of bed siltation due to livestock grazing and poaching and little silt trapping, as shown by the photo of Subreach 2 (Figure 2.8). However, although riparian cover may reduce silt reaching the river, silt will also settle around fallen trees and create local high levels of siltation (Figure 2.8).

Figure 2.8: Left photo showing the agricultural land use on the bank top and lack of riparian vegetation, taken at Subreach 2. Right photo showing overgrown riparian vegetation, taken at Subreach 6.

- Two new metal gates that will allow livestock to cross the river at one dedicated point, at designated times. To enable livestock to access the fields on each side of the river channel but otherwise exclude livestock from the river banks.

- A slip-rail set that allows livestock periodic access to the river for conservation grazing and vegetation management on the banks. The slip-rail set will allow livestock access to the river at certain times of the year to graze the vegetation on the banks of the river and act as a management tool to prevent unchecked growth. The slip-rail set has the dual benefit of preventing livestock river bank access throughout the year, but allowing it infrequently to provide management. Erasing the need for employing more costly management techniques.

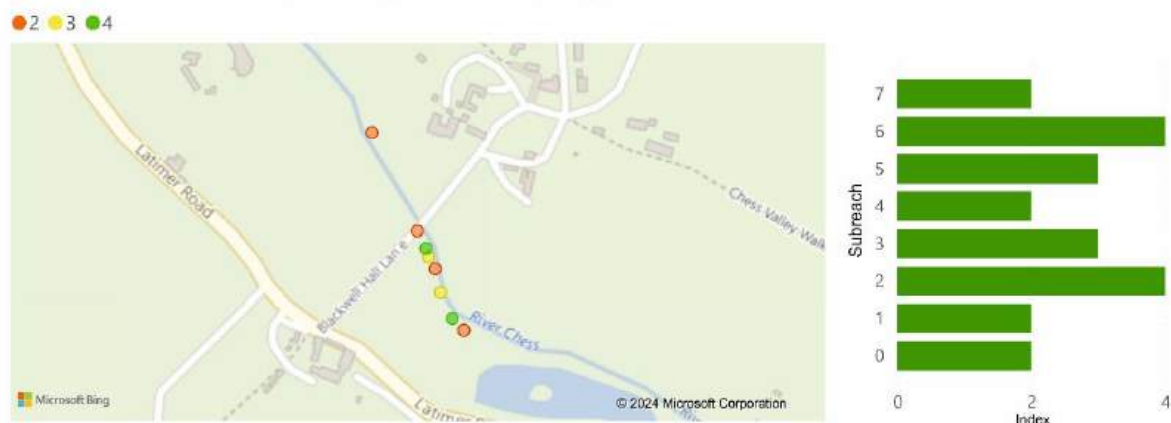
INDEX 9: Number of aquatic vegetation morphotypes

A detailed breakdown of changes in aquatic vegetation are shown in Figure 2.9. Index 9 indicates the number of different aquatic vegetation morphotypes identified by the trained citizen science surveyors. In this instance 'morphotype' describes groups of vegetation with the same overall shape and function (e.g. fine-leaved plants submerged under the water, broad-leaved plants emerging from the water, plants floating freely on the water surface, filamentous algae). The greater the number of aquatic vegetation morphotypes the higher the score, and the more biodiverse the aquatic vegetation is within the reach. The numbers of aquatic vegetation morphotypes was relatively good on average within the site however, Figure 2.9 illustrates the variability of Index along the channel, with the highest scores at subreach two

and subreach six. The numbers of aquatic vegetation morphotypes are likely to change based on light levels in the channel and marginal vegetation trailing into the channel.

Figure 2.9: Index 9 at each subreach.
