Chesham Moor - Baseline report

Part A – Modular River Survey

Smarter Water Catchment Programme

July 2024

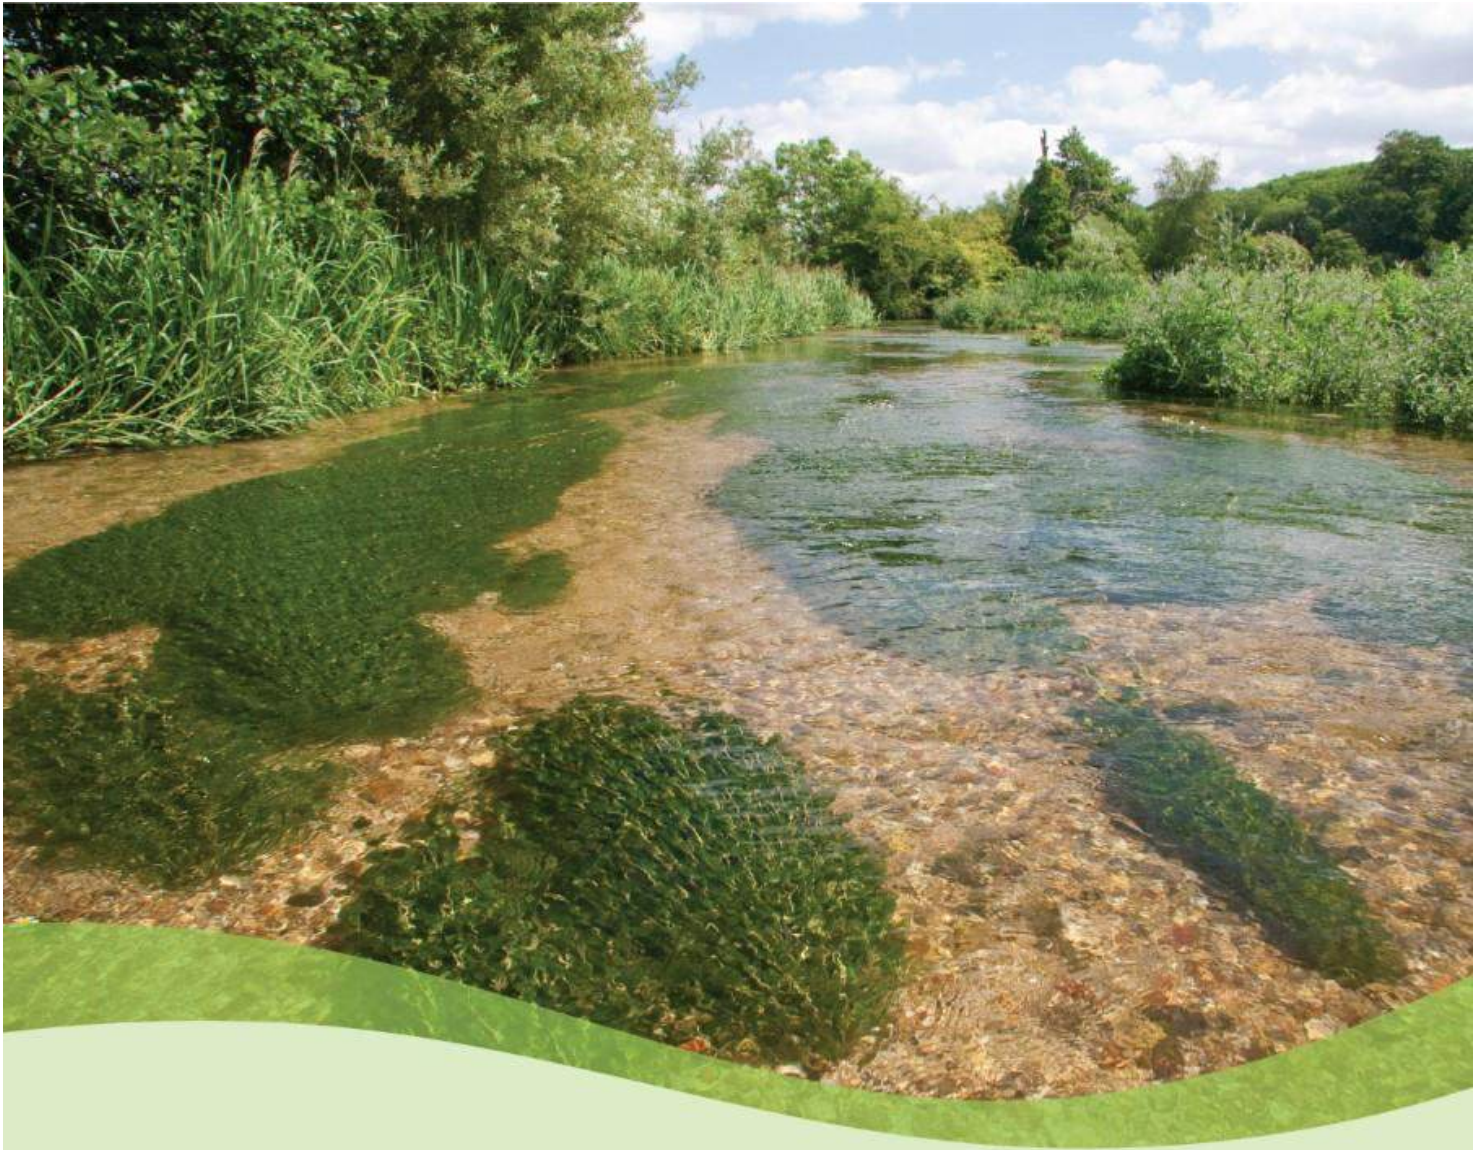
Figure 1.1 General views of the baseline (pre-restoration conditions of the River Chess at the Chesham Moor site. Taken at subreach 6 (April 2023)

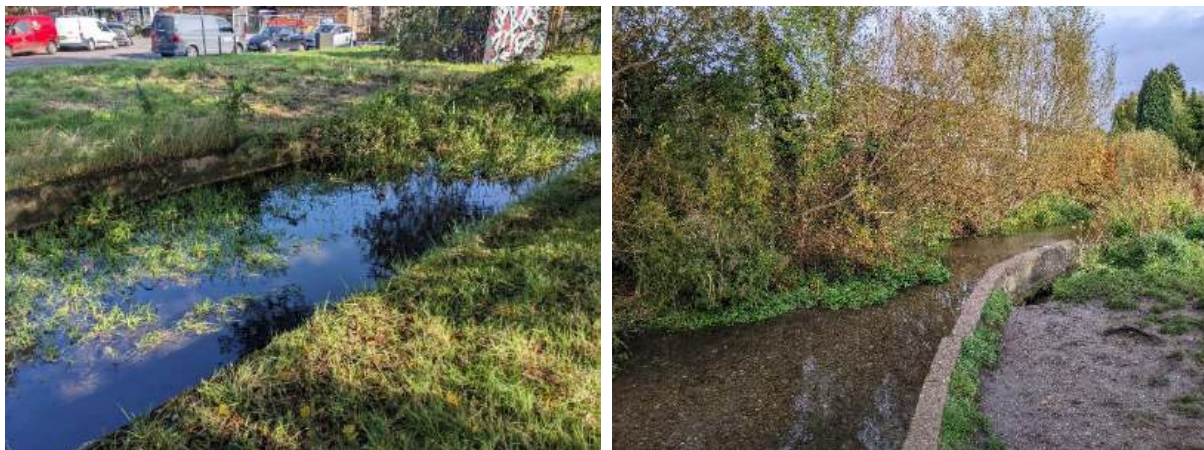
The Pre-Project MoRPH data (Figure 2.5 and Figure 2.6) shows the number of flow types (Index 1) were on average low (1-2) (Figure 2.2), about the same as the UK chalk Stream average, but well below what the river would naturally contain (pre-modification). Index 2 also illustrates that the highest energy flow types were smooth, rippled or unbroken standing waves.

Figure 2.2: Examples of the lack of flow diversity and the flow types smooth and rippled. Taken from Subreach 2 (left, October 2023) and Subreach 7 (right, October 2022).

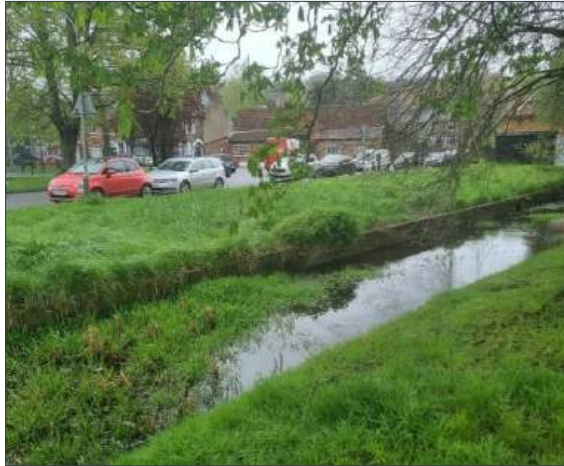
diversity in the aquatic vegetation morphotypes⁴ (Index 9) and riparian vegetation structure (Index 11) across the site which demonstrates the low complexity of the aquatic and riparian vegetation. This was likely to be reflecting the variability of the riparian vegetation which was very sparse at some subreaches and overgrown at other subreaches, causing extensive channel shading (Figure 2.3). The bank top along the subreach is managed to restrict growth of vegetation, which is likely to be preventing the long-term regrowth of long grass, shrubs and small trees. This is likely the reason for the low complexity of riparian vegetation recorded.

Figure 2.3: Evidence of the variability of riparian vegetation as it was very sparse at some subreaches (left taken at Subreach 1, April 2023) and overgrown at other subreaches (photo in Figure 2.2, right taken at Subreach 7, October 2022).

A detailed breakdown of the riparian habitat along the channel within the site is shown in Figure 2.9. Index 10 and 11 illustrate the physical habitat complexity of the riparian margins and the complexity of the riparian vegetation. Along the site, there was a high level of variability of the riparian vegetation which was very sparse at some subreaches and overgrown at other subreaches, causing extensive channel shading. Subreach 7 displayed the highest amount of physical habitat complexity and vegetation complexity, as shown in Figure 2.3.

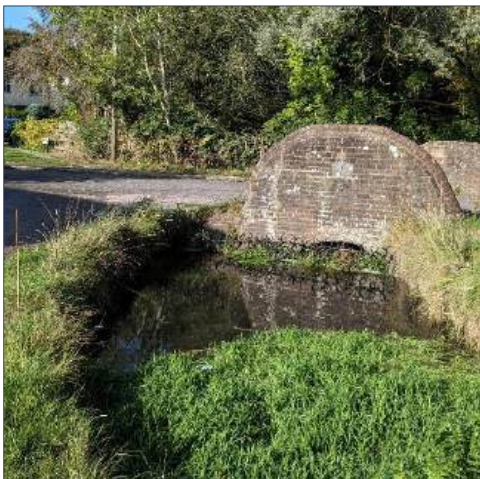
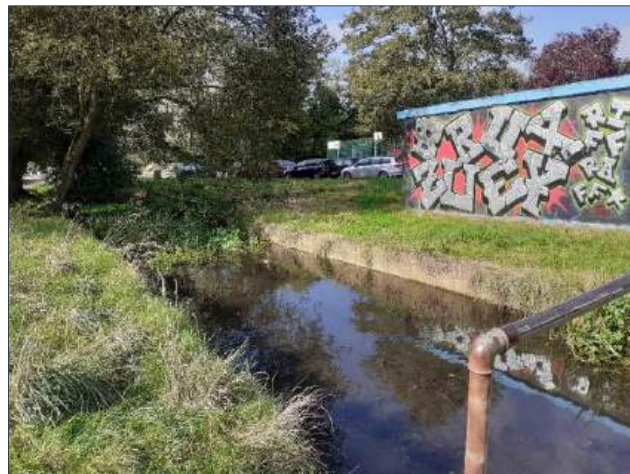
Human pressure and channel reinforcement was identified at the majority of the subreaches. This was linked closely to the road culvert at the upstream end of the site (Subreach 1), the concrete channel banks and concrete footbridge (Figure 2.4). Additionally, human pressure on the bank top is visible by the limited riparian vegetation diversity, which is likely due to maintenance preventing long grass, shrubs and trees from establishing. No non-native plant species were recorded at any of the subreaches.

Figure 2.4: Photos of human pressure at the site. Upstream culvert taken at Subreach 1 (left, October 2023), and concrete lined channel banks taken at Subreach 4 (right, October 2023).

The aims of our restoration project are to reverse the detrimental effects of past physical alterations to the channel and so restore a more diverse and naturally functioning river. This will allow the chalk stream to have a more natural flow and for there to be a better relationship between it and the surrounding landscape. Our restoration works plan to remove the concrete walls and widen the main channel to

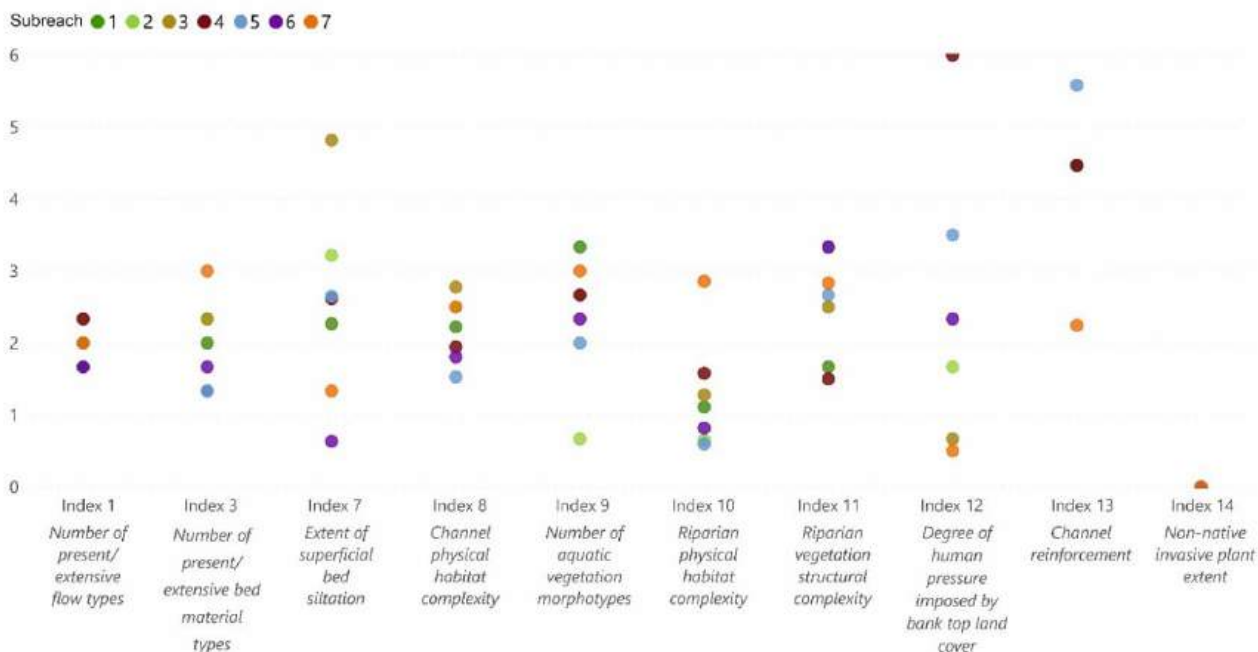
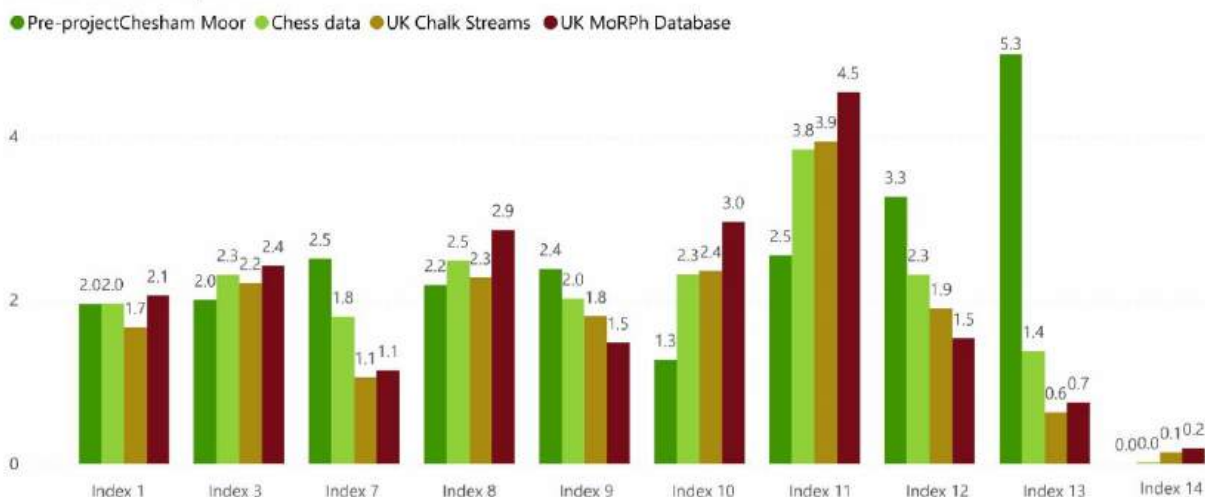
Figure 2.5 Summary of the pre-restoration (baseline) averages of the MoRPh indexes⁵ per subreach from the Chesham Moor site. Also shown are index value comparisons for all MoRPh surveys on the River Chess (light green), UK average chalk stream values (brown), and average values for all rivers within the Citizen Science MoRPh database (red).

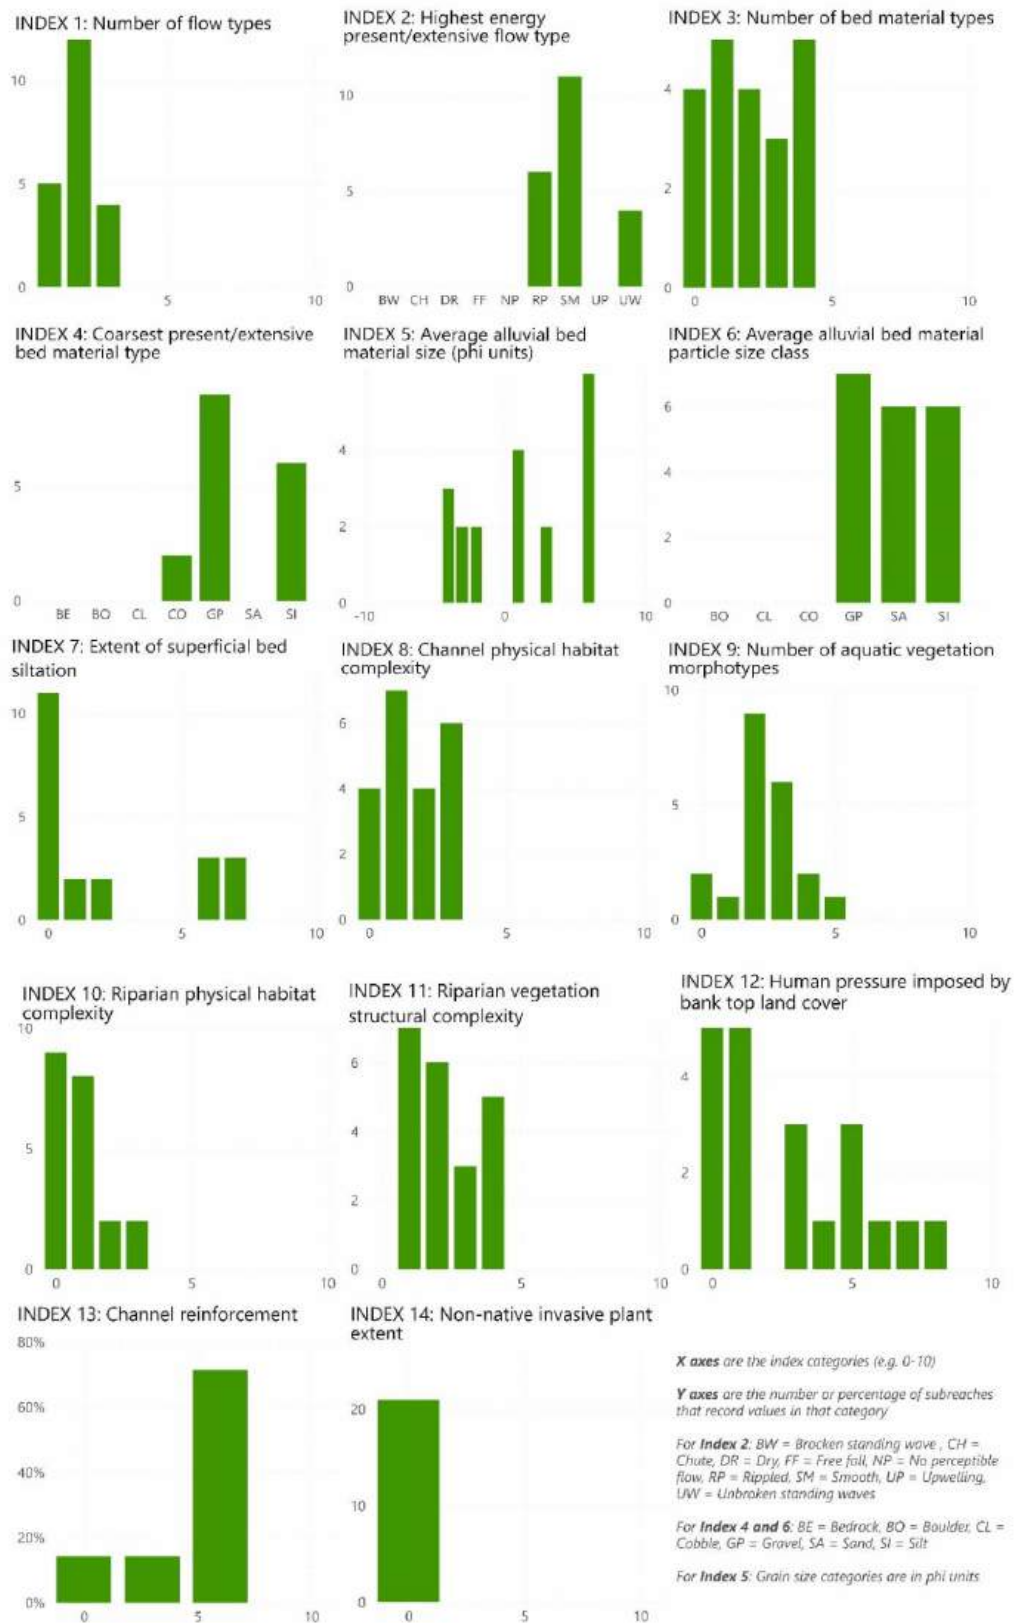
Figure 2.6 Frequency distributions of MoRPH Index values 1-11 for the pre-restoration (baseline) surveys of the Chesham Moor site.

The frequency distributions illustrate the low physical habitat complexity of the site due to the low channel physical habitat (Index 8) and riparian physical habitat (Index 10). Similarly, there was little

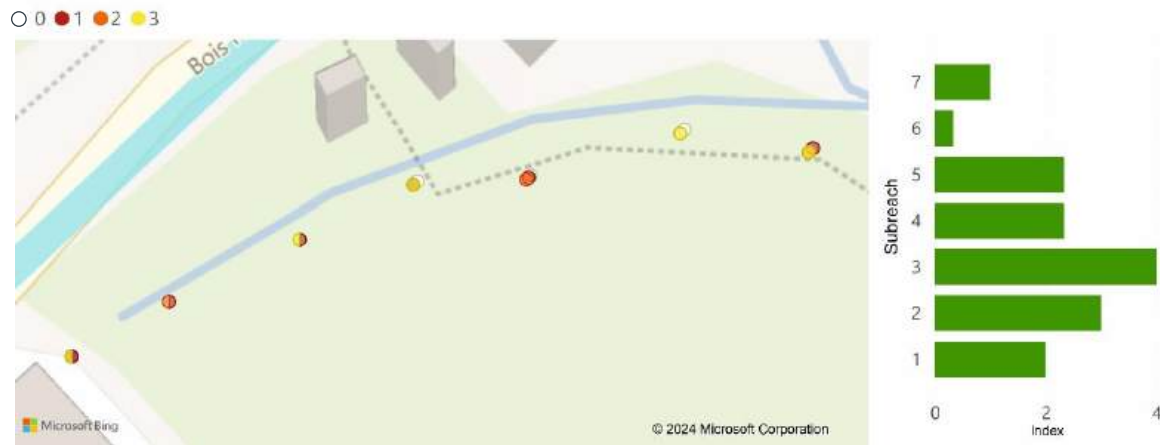
Figure 2.7 (Index 7) illustrates the extent of silt of the channel bed recorded by the trained citizen science surveyors. UK chalk streams are expected to have relatively low levels of silt across the channel bed as a high proportion of the flow is groundwater fed⁶. Within the site, the extent of bed siltation recorded varied extensively and there was a higher extent of bed siltation at the upstream end of the site. Subreach 3 recorded the average highest extent of bed siltation and Subreach 6 had the lowest average extent of bed siltation. This is likely related to the overall channel conditions at the upstream end of the site and the increase in-channel vegetation obscuring the channel bed towards the downstream end of the site (Figure 2.8).

Figure 2.7: Index 7 at each subreach.

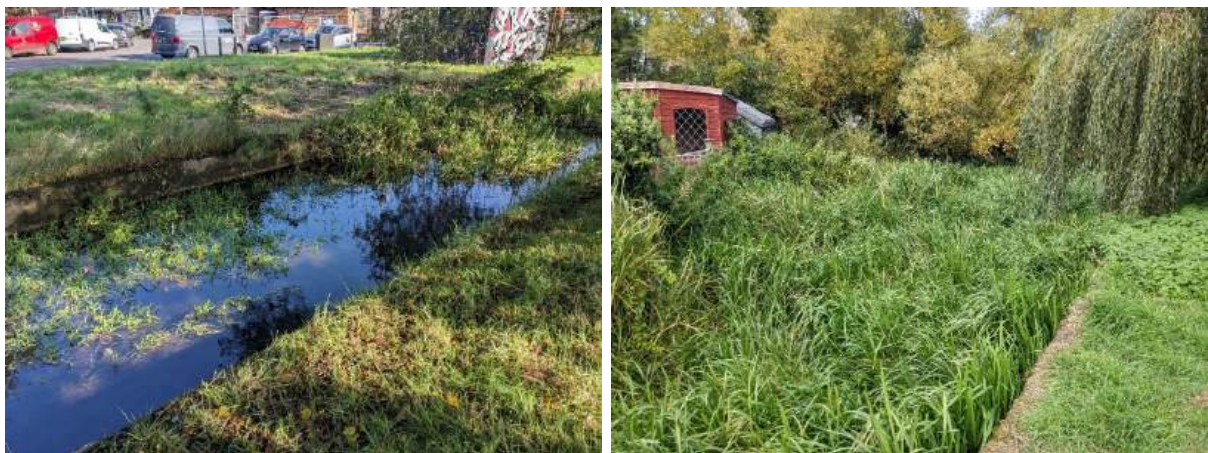
Figure 2.8: Evidence of overwide conditions taken at Subreach 2 (left, October 2023) and dense in-channel vegetation obscuring the channel bed taken at Subreach 6 (right, August 2022).

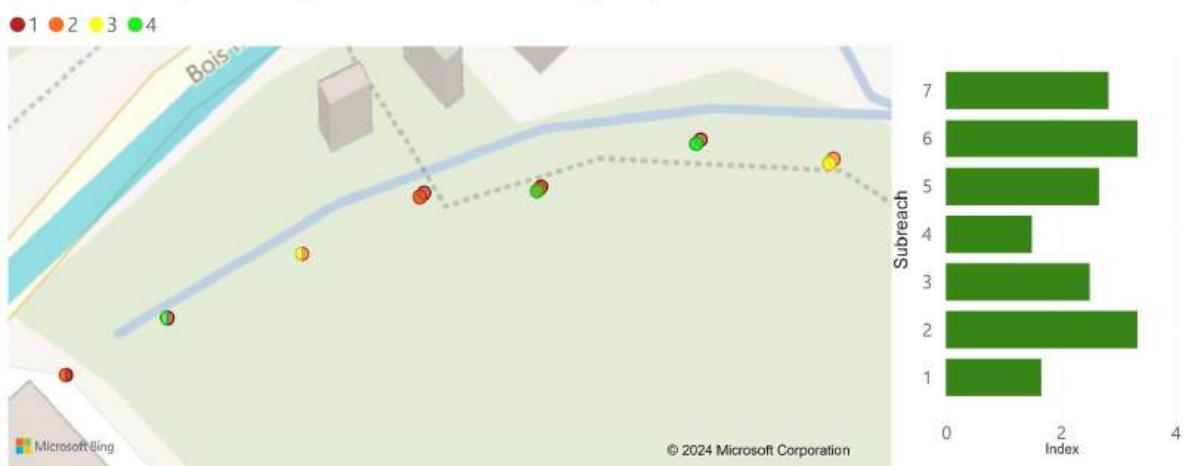
Figure 2.9: Index 10 and Index 11 at each subreach.
