# Hollow Way Lane - Baseline report

## Part A – Modular River Survey

Smarter Water Catchment Programme

July 2024

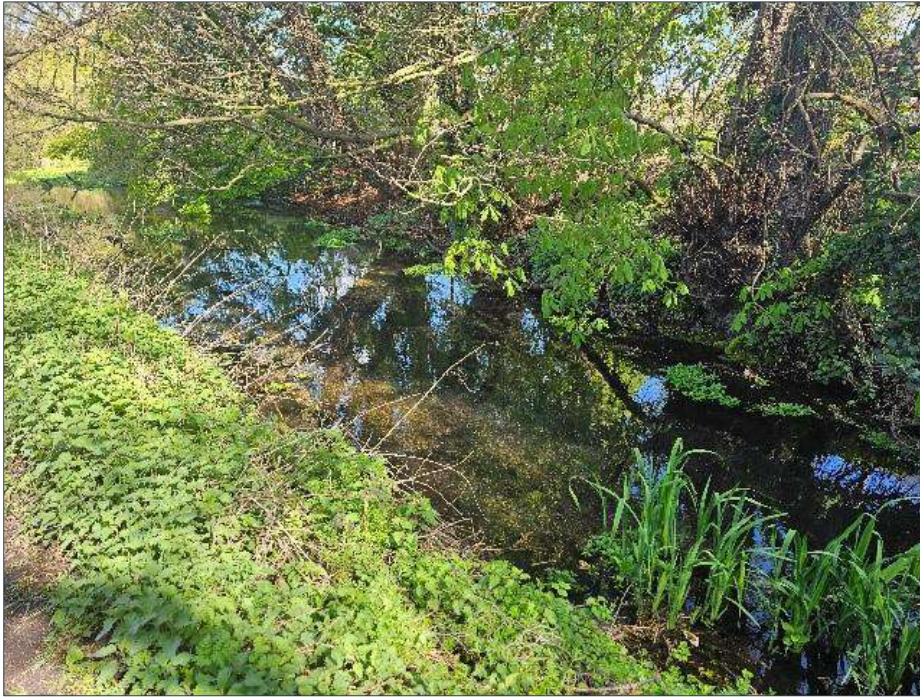
**Figure 1.1:** General view of the Little Chess at the Holloway Lane site taken during the baseline (pre-restoration) MoRPh surveys (subreach 2)

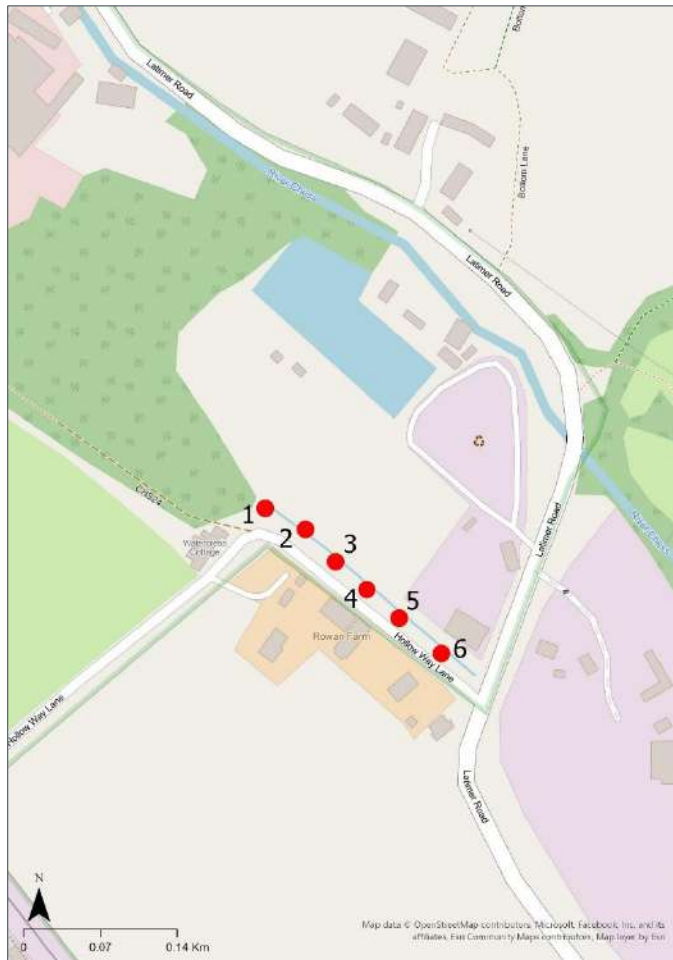
**Figure 2.1** Map of the Little Chess at the Holloway Lane site, showing the locations of the MoRPH subreaches (red circles).

Baseline surveys were undertaken on six subreaches<sup>3</sup> of the Little Chess (Figure 2.1) at the Holloway Lane site in April 2023. The river has been affected by centuries of historical modification, including canalisation and drainage for flood defence, farming and fishing pursuits, urban development and for industries such as milling. At the Holloway Lane site, it is likely that the channel was artificially created, as shown by the overwide and straight nature of the channel. Historically, the channel flowed alongside the Chesham Sewage Treatment works but in the late 19<sup>th</sup> century, the sewage treatment works moved further downstream. In 2024 the Sewage Treatment works are located south of Latimer Rd. The site is constrained by land use as the channel flows parallel to Holloway Lane Rd and is culverted under Latimer Rd at the downstream end (Figure 2.1). The proximity to the road has limited the riparian cover on the right bank (Figure 2.4).

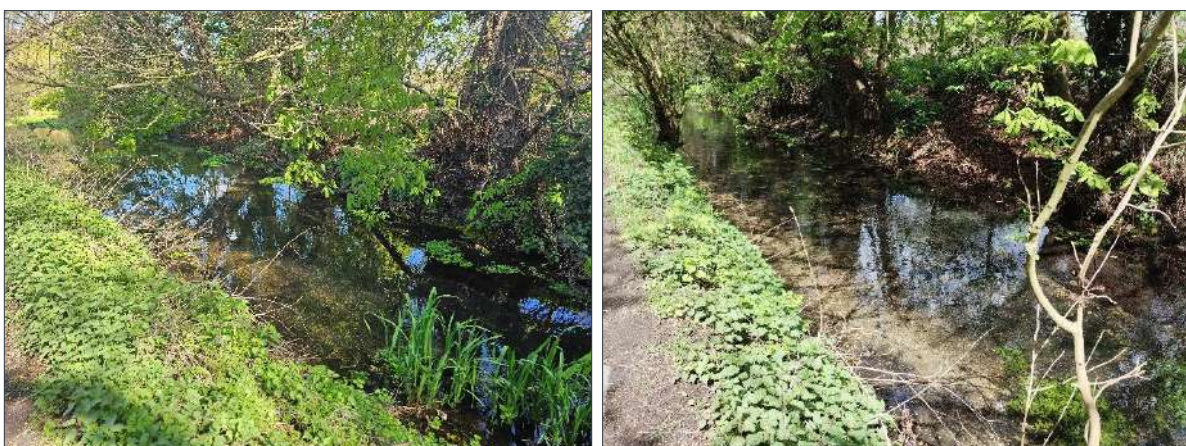
The Pre-Project MoRPH data (Figure 2.5 and 2.6) shows the number of flow types (Index 1) were on average relatively low (1-3) (Figure 2.2), similar to the UK chalk stream average, but well below the number of flow types that the river should naturally contain (pre-modification). Index 2 illustrates that the highest energy flow types were unbroken standing wave, rippled and smooth.

**Figure 2.2:** Evidence of the lack of flow diversity taken at Subreach 2 (left) and Subreach 3 (right).

- The channel currently has on average little flow diversity or energy, and on average higher amounts of bed siltation than expected for UK chalk streams. Siltation scores reduce from the most upstream to downstream sites.

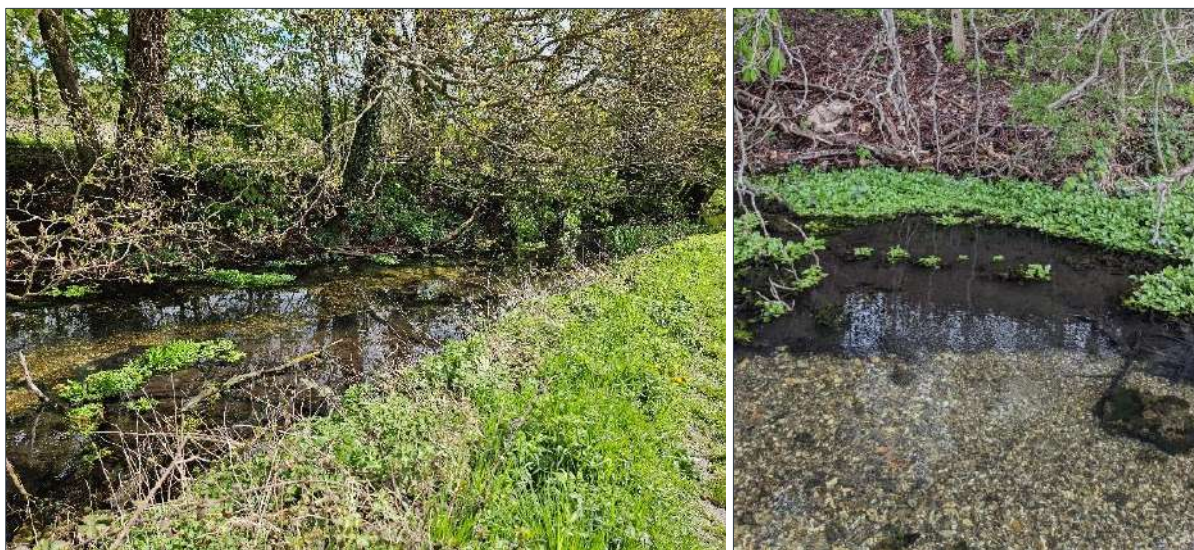
The coarsest bed material size (Index 4) on average covering the river bed was gravel, and the most common bed material (Index 6) on average was sand, then gravel. The extent of bed siltation (Index 7) was very variable, ranging from 0 to 10. Therefore, the average was much higher than the UK chalk

stream average. The extent of bed siltation is highest at the upstream end of the site and reduces towards the downstream end of the site (Figure 2.3). This is likely reflecting the overwide and over-deep nature of the channel at the upstream end of the site (subreach 1 recorded a width of 8.5m and subreach 6 had a width of 2.5m).

**Figure 2.3:** Photos of the variation in bed siltation which is higher upstream in the site shown by the left photo (taken at Subreach 1) and the right photo (taken at Subreach 5).

A detailed breakdown of bed siltation along the channel within the site is shown in Figure 2.7. Index 7 illustrates the average extent of silt of the channel bed recorded by the trained citizen science surveyors. UK chalk streams are expected to have relatively low levels of silt across the channel bed as a high proportion of the flow is groundwater fed. Within the site, the extent of bed siltation recorded varied extensively and there was a higher extent of bed siltation at the upstream end of the site. This is likely related to the overall channel conditions at the upstream end of the site (Figure 2.3).

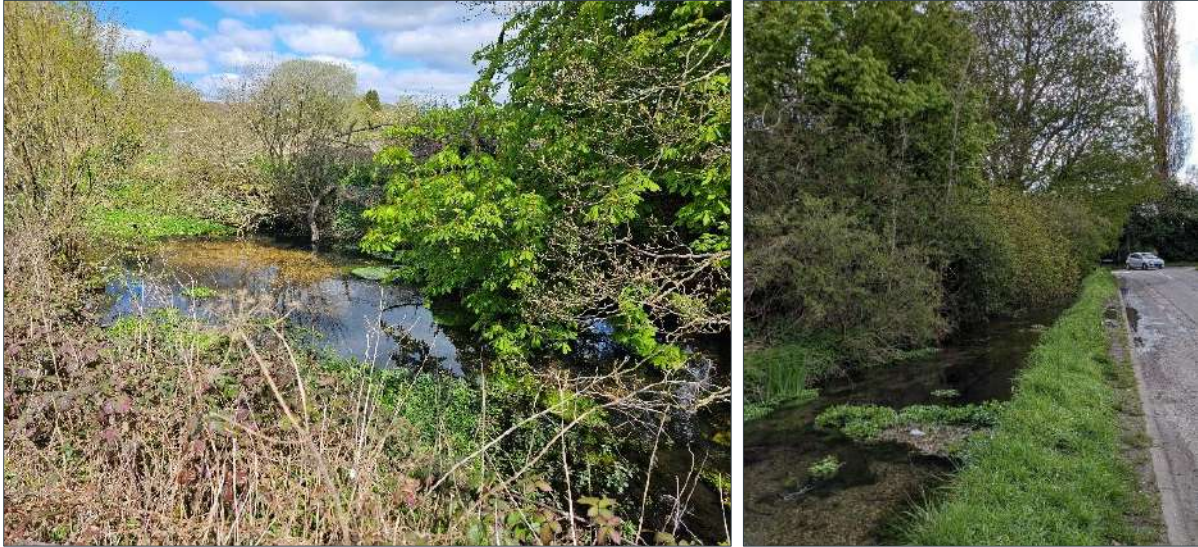
Channel physical habitat complexity (Index 8) and riparian physical habitat complexity (Index 10) were both close to the average for UK chalk streams and the Chess catchment (Figure 2.4). The frequency distributions for both illustrate the low physical habitat complexity of the site due to the low amount of channel physical habitat (Index 8) and riparian physical habitat (Index 10). The riparian vegetation structural complexity (Index 11) was also about average compared to other UK chalk streams. This is likely reflecting the lack of riparian diversity on the right bank due to the proximity of Holloway Lane Rd (Figure 2.4).

**Figure 2.4:** Photos of the average riparian physical habitat and vegetation complexity and the restriction on complexity due to the proximity of Holloway Lane road (right). Taken at Subreach 1 (left) and Subreach 5 (right).

A detailed breakdown of riparian vegetation complexity within the site is shown in Figure 2.8. Index 11 illustrates the complexity of the riparian vegetation and a higher number represents greater diversity in the vegetation. At the downstream end of the site, the riparian vegetation complexity is lower which is likely related to the increased proximity of Holloway Lane road and the culverted section under Latimer Road (Figure 2.4).

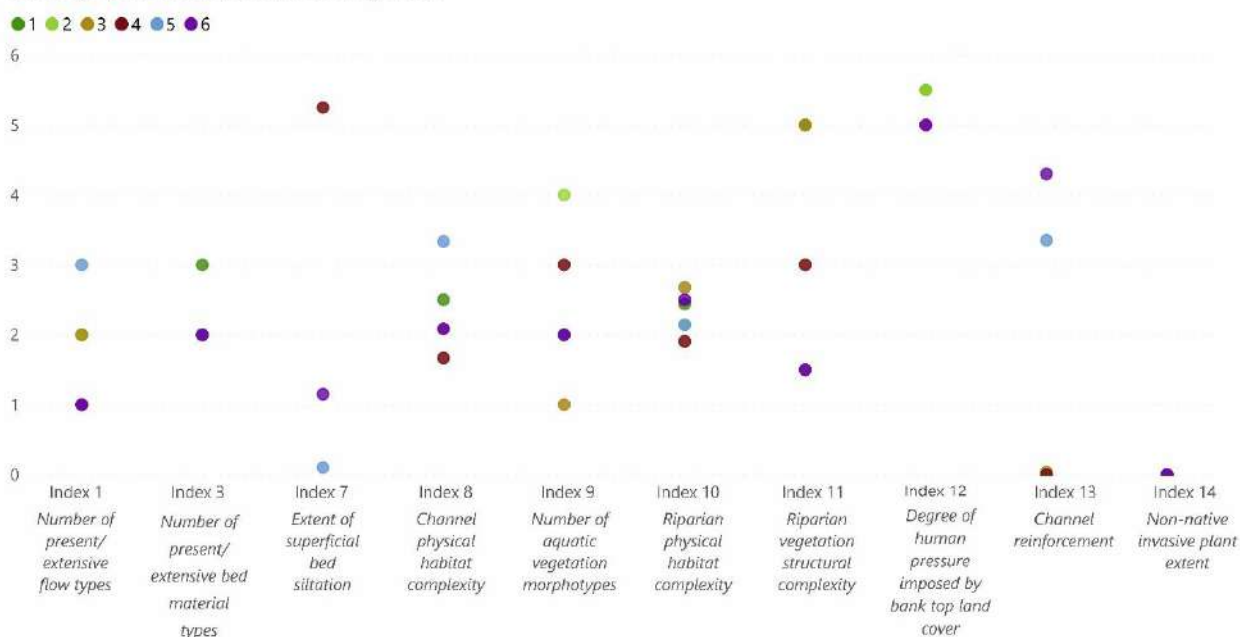
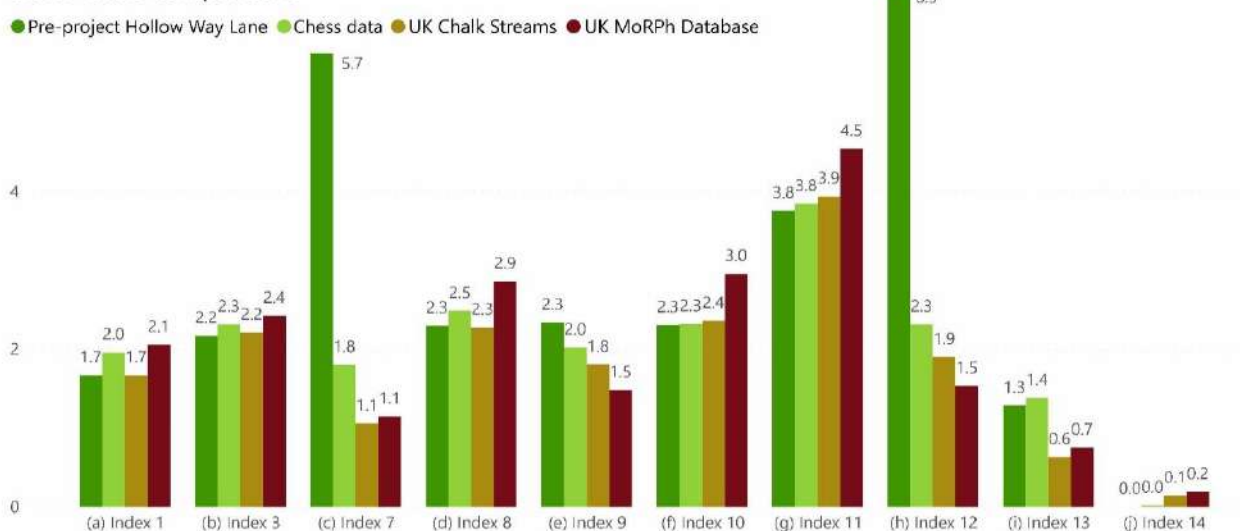
At all subreaches, medium to high amounts of human pressures on the bank top (Index 12) were recorded, reflecting the proximity of the channel to Holloway Lane Rd. However, channel reinforcement was only identified at a few subreaches (Index 13). Channel reinforcement was recorded at the downstream end of the site at subreaches five and six. No non-native species (Index 14) were recorded at any of the subreaches.

**Figure 2.5** Summary of the pre-restoration (baseline) averages of the MoRPh indexes<sup>5</sup> per subreach from the Holloway Lane site. Also shown are index value comparisons for all MoRPh surveys on the Little Chess (light green), UK average chalk stream values (brown), and average values for all rivers within the Citizen Science MoRPh database (red).

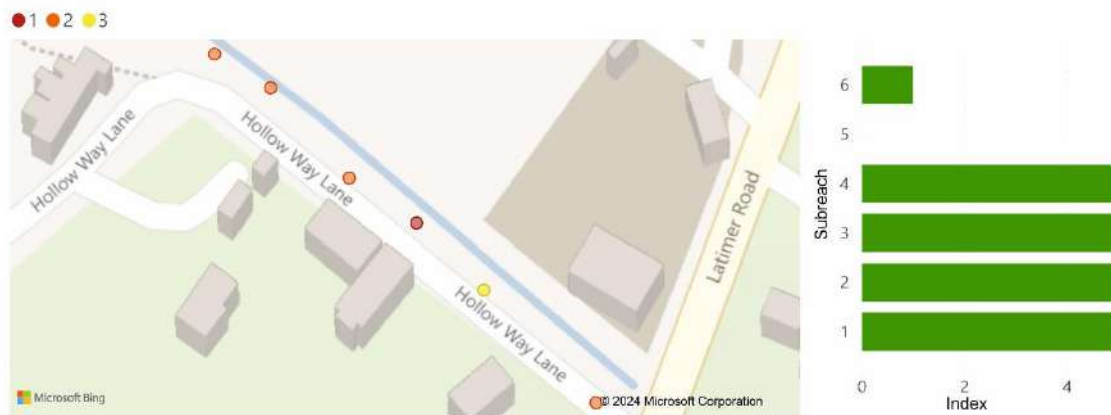
**INDEX 7: Extent of superficial bed siltation**

**Figure 2.7:** Index 7 at each subreach.

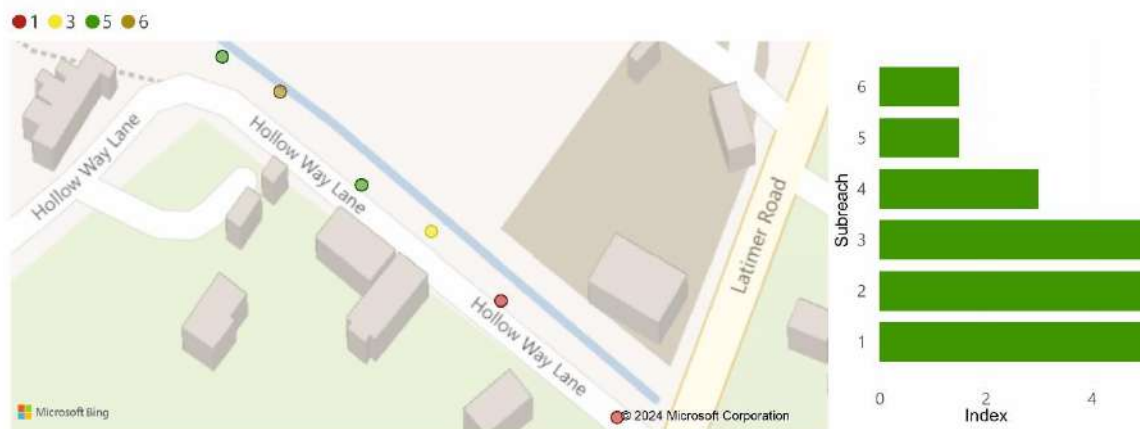
**INDEX 11: Riparian physical habitat complexity**

**Figure 2.8:** Index 11 at each subreach.
