Scotsbridge Mill - Baseline report

Part A – Modular River Survey

Smarter Water Catchment Programme

July 2024

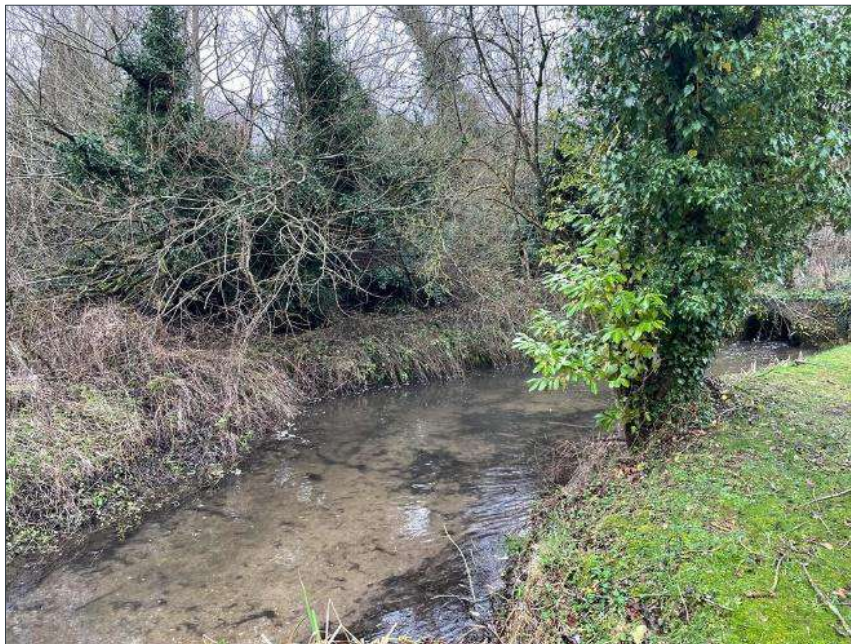
Figure 1.1 General view of the main River Chess during the baseline (pre-restoration) MoRPh surveys at Scotsbridge Mill, taken from Subreach 4 (March 2023).

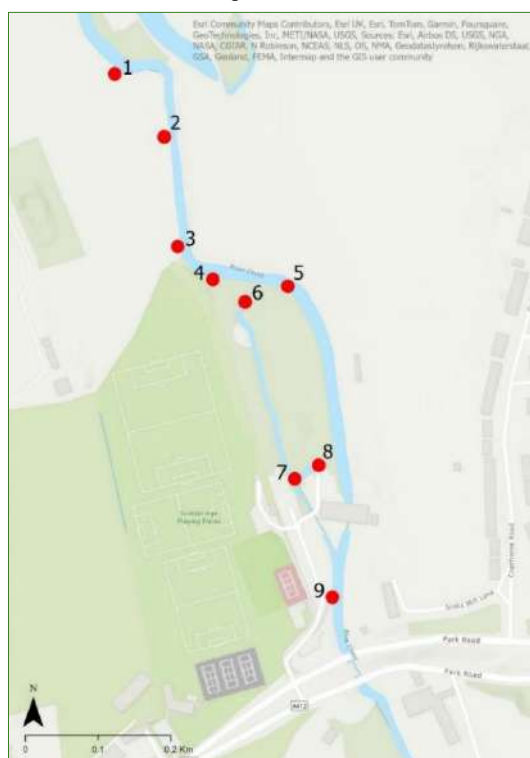
Figure 2.1 Map of the River Chess at the Scotsbridge Mill site, showing the locations of the MoRPH subreaches (red circles).

Baseline surveys were undertaken on nine subreaches³ of the River Chess (Figure 2.1) at Scotsbridge Mill in January, June and November 2023. The River Chess has been affected by centuries of historical modification, including canalisation and drainage for flood defence, farming and fishing pursuits, urban development and for industries such as milling.

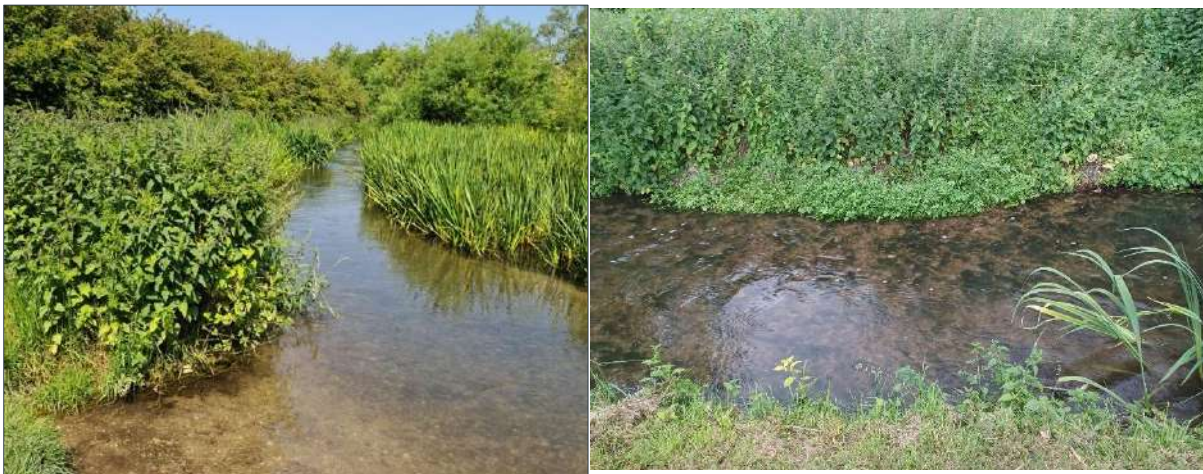
Figure 2.2 Photos of the flow conditions and in-channel conditions of the River Chess at the Scotsbridge Mill site. The photos show there was a lack of flow diversity, energy and very few numbers of aquatic vegetation morphotypes. The left photo shows gravel material covering the channel bed. Taken at Subreach 1 (left, June 2023) and Subreach 8 (channel bypass) (right, June 2023).

The coarsest bed material size (Index 4) covering the river bed at the majority of subreaches was gravel material. The extent of bed siltation on average was very low, as would be expected from chalk streams where a high proportion of flow is groundwater fed⁵ (Figure 2.2).

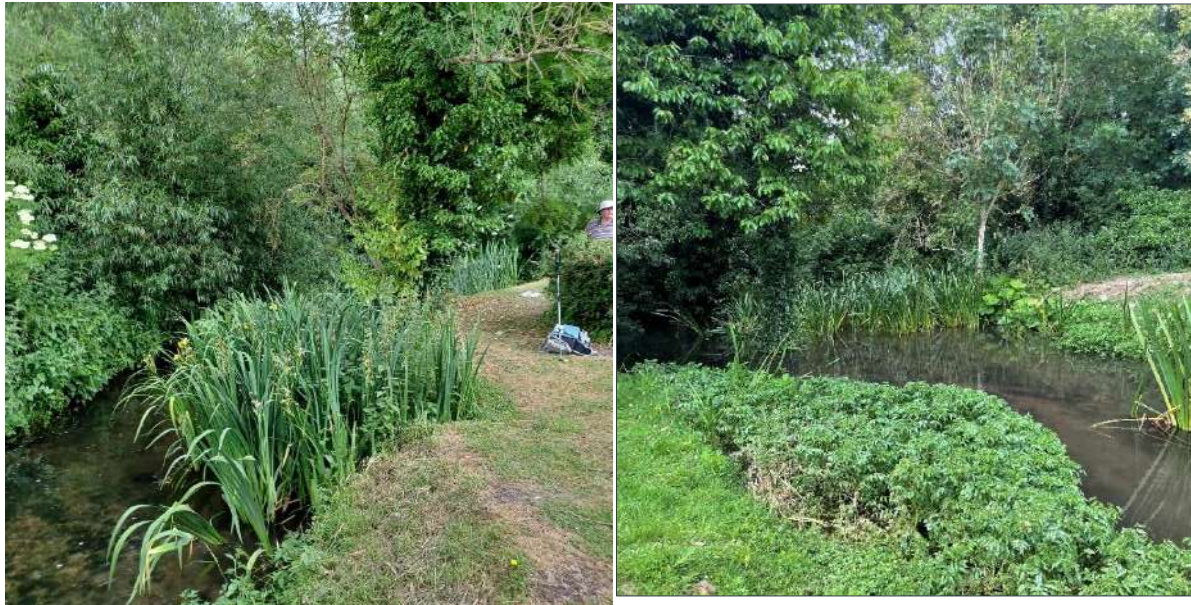
overgrown in some sections (Figure 2.3). Through the site, the channel is constrained by the commercial and recreational land use which includes green space and leisure (restaurant and car parks).

Figure 2.3: Photos of the riparian vegetation of the River Chess at the Scotsbridge Mill site. The photos show moderate conditions and the lack of riparian vegetation diversity and complexity. Taken at Subreach 8 (channel bypass) (left, June 2023) and Subreach 5 (right, June 2023).

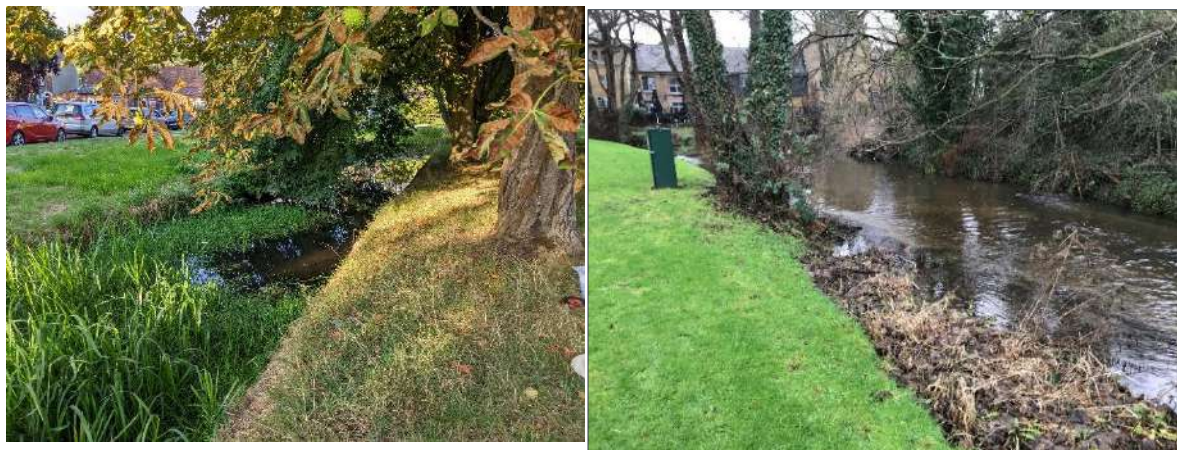
Human pressures on the bank top were recorded at the majority of the subreaches, and channel reinforcement was identified at a small amount of the subreaches. Human pressures on the site are linked to the artificially straight nature of the channel, the historic industrial land use and the present commercial land use (Figure 2.4). No non-native invasive plant species were recorded at any of the subreaches.

Figure 2.4 Photos of the bank top showing the human pressures on the land use. Taken at Subreach 7 (left, January 2023) and Subreach 9 (right, June 2023).

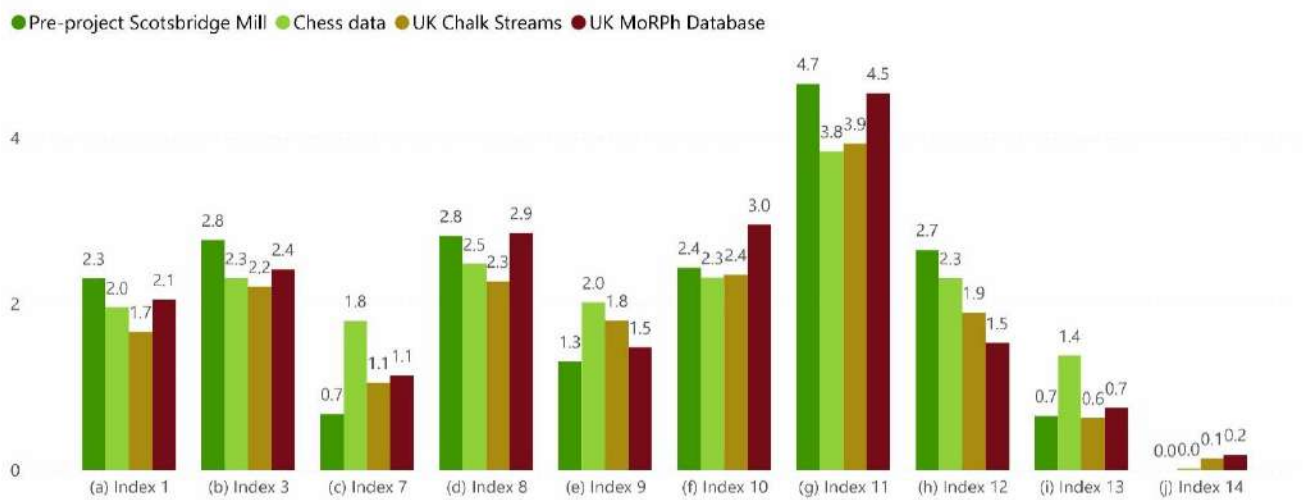
The pre-project MoRPh data (Figure 2.5 and Figure 2.6) shows the number of flow types (Index 1) were on average similar to the UK chalk stream average, but well below what the river would naturally contain (pre-modification). The number of flow types and energy of the flows had a small distribution, reflecting a lack of flow diversity through the site (Figure 2.2). The average numbers of aquatic vegetation morphotypes⁴ (Index 9) was also low (0-2), below the UK chalk stream average.

Channel physical habitat complexity (Index 8) and riparian physical habitat complexity (Index 10) were both on average slightly higher than the average for UK chalk streams and the River Chess catchment. However, the data illustrates the limited diversity of channel physical habitat (Index 8) and riparian physical habitat (Index 10) (Figure 2.3) within the site. Similarly, there was on average, a small amount of aquatic vegetation morphotypes⁴ (Index 9), indicating limited diversity.

Figure 2.5 Summary of the pre-restoration (baseline) averages of the MoRPh indexes⁶ per subreach. Also shown are index value comparisons for all MoRPh surveys on the River Chess (green), UK average chalk stream values (orange), and average values for all rivers within the Citizen Science MoRPh database (dark red).

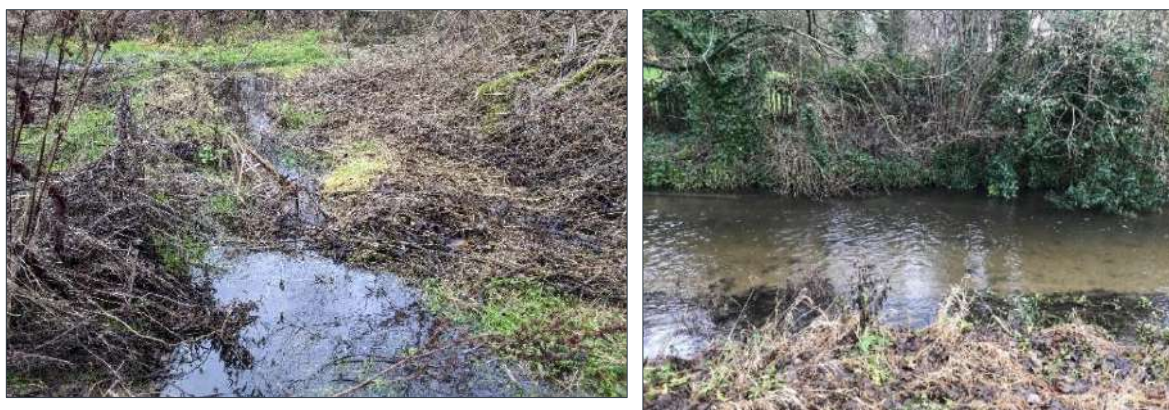
Figure 2.8 Photos of subreach 6 (left) and subreach 9 (right) illustrating the difference between a subreach showing one type of bed material and three types of bed material.

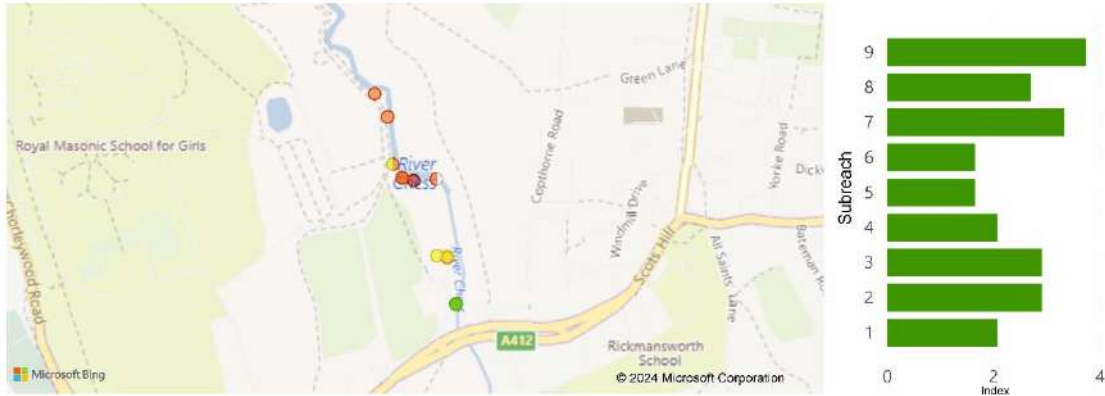
Figure 2.9: Index 8 and Index 10 at each subreach.

A detailed breakdown of physical habitat complexity within the site for the channel and the riparian margins shown in Figure 2.9. Within the site, the complexity of physical habitat varies along the river for both the channel and riparian margins. Subreach three has the highest in-channel and riparian physical habitat complexity.
